(6) National Dam Inspection Program.  
Number  
**DOVERSPIKE NO. 2 DAM**  
(NDI I.D. PA-00810,  
DER I.D. 33-57), Ohio River basin,  
Caylor Run, Jefferson County,  
Pennsylvania.  
**PHASE I INSPECTION REPORT,**  
**NATIONAL DAM INSPECTION PROGRAM**

NAME OF DAM: Doverspike No. 2 Dam  
STATE LOCATED: Pennsylvania  
COUNTY LOCATED: Jefferson  
STREAM: Caylor Run, Tertiary Tributary of Mahoning Creek  
SIZE CLASSIFICATION: Intermediate  
HAZARD CLASSIFICATION: Significant  
OWNER: J. C. Enterprises  
DATE OF INSPECTION: April 24, 1980 and May 1, 1980

DOVERSPIKE NO. 1 DAM  
NDI I.D. PA-810  
DER I.D. 33-57  
APRIL 24, 1980

PHASE I REPORT  
NATIONAL DAM INSPECTION PROGRAM  
DOVERSPIKE NO. 2. DAM  
NDI I.D. PA-810  
DER I.D. 33-57

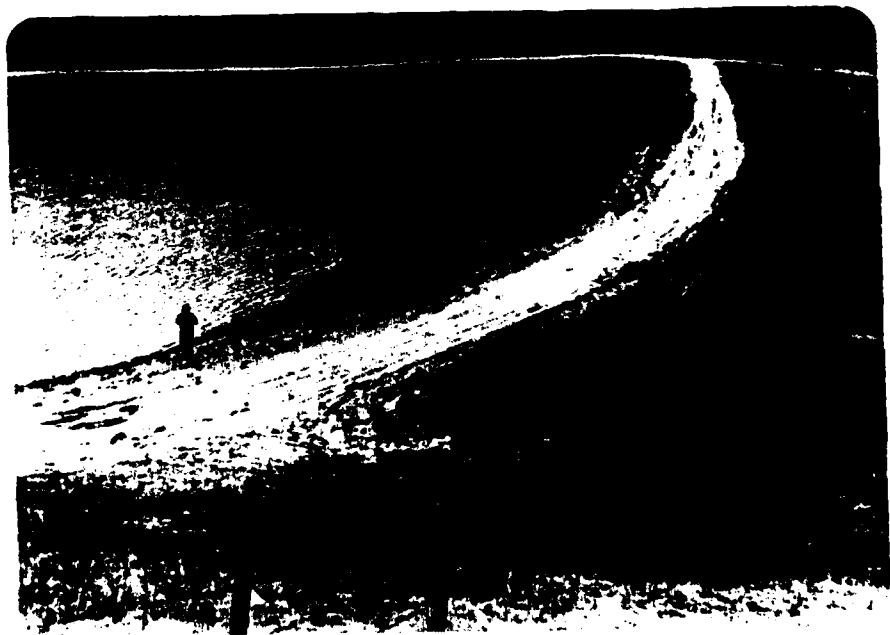
The crest of the dam was surveyed relative to the pool elevation on the date of inspection, and the crest profile is illustrated in Plate 4. A low area found on the crest of the dam near the right abutment appears to be the intended spillway overflow section for the reservoir. The downstream and upstream slopes of the dam were surveyed and found to be approximately 9H to 1V and 3H to 1V, respectively.

VISUAL EXAMINATION OF	OBSERVATIONS	REMARKS OR RECOMMENDATIONS
CONCRETE WEIR	A low spot on the crest of the dam near the right abutment appears to be the intended emergency overflow section for the dam.	
APPROACH CHANNEL	Lake	
DISCHARGE CHANNEL	None	
BRIDGE AND PIERS	None

Photograph No. 2  
crest (looking southeast). For ground: low area  
on crest, possible emergency spillway.

3.2 Evaluation. The overall condition of the embankment is considered to be good. Installation of an overflow spillway with adequate discharge capacity, erosion protection and discharge channel is considered to be required.

In view of the above conditions, it is recommended that hydrologic and hydraulic features of the dam be evaluated by an experienced professional engineer to prepare plans to provide adequate spillway facilities to maintain a prescribed normal pool elevation and to have adequate flood discharge capacity.

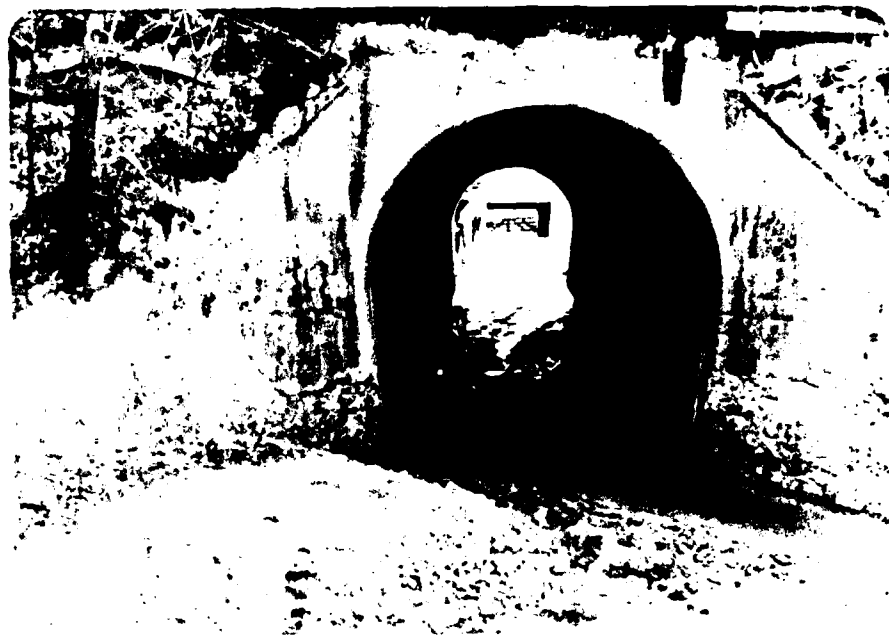
Photograph No. 3

this stream flows under a railroad embankment, then shortly thereafter joins Pine Run, a secondary tributary of Mahoning Creek. A further description of the downstream conditions is included in Section 1.2d.

A culvert under railroad embankment (approximately one mile downstream).

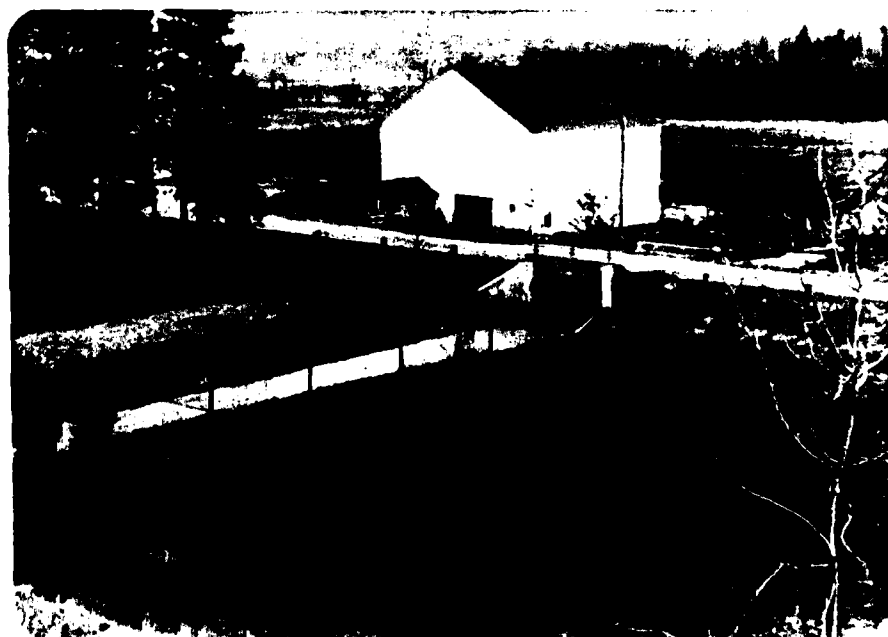
Photograph No. 4

Farm, immediately downstream from railroad embankment.

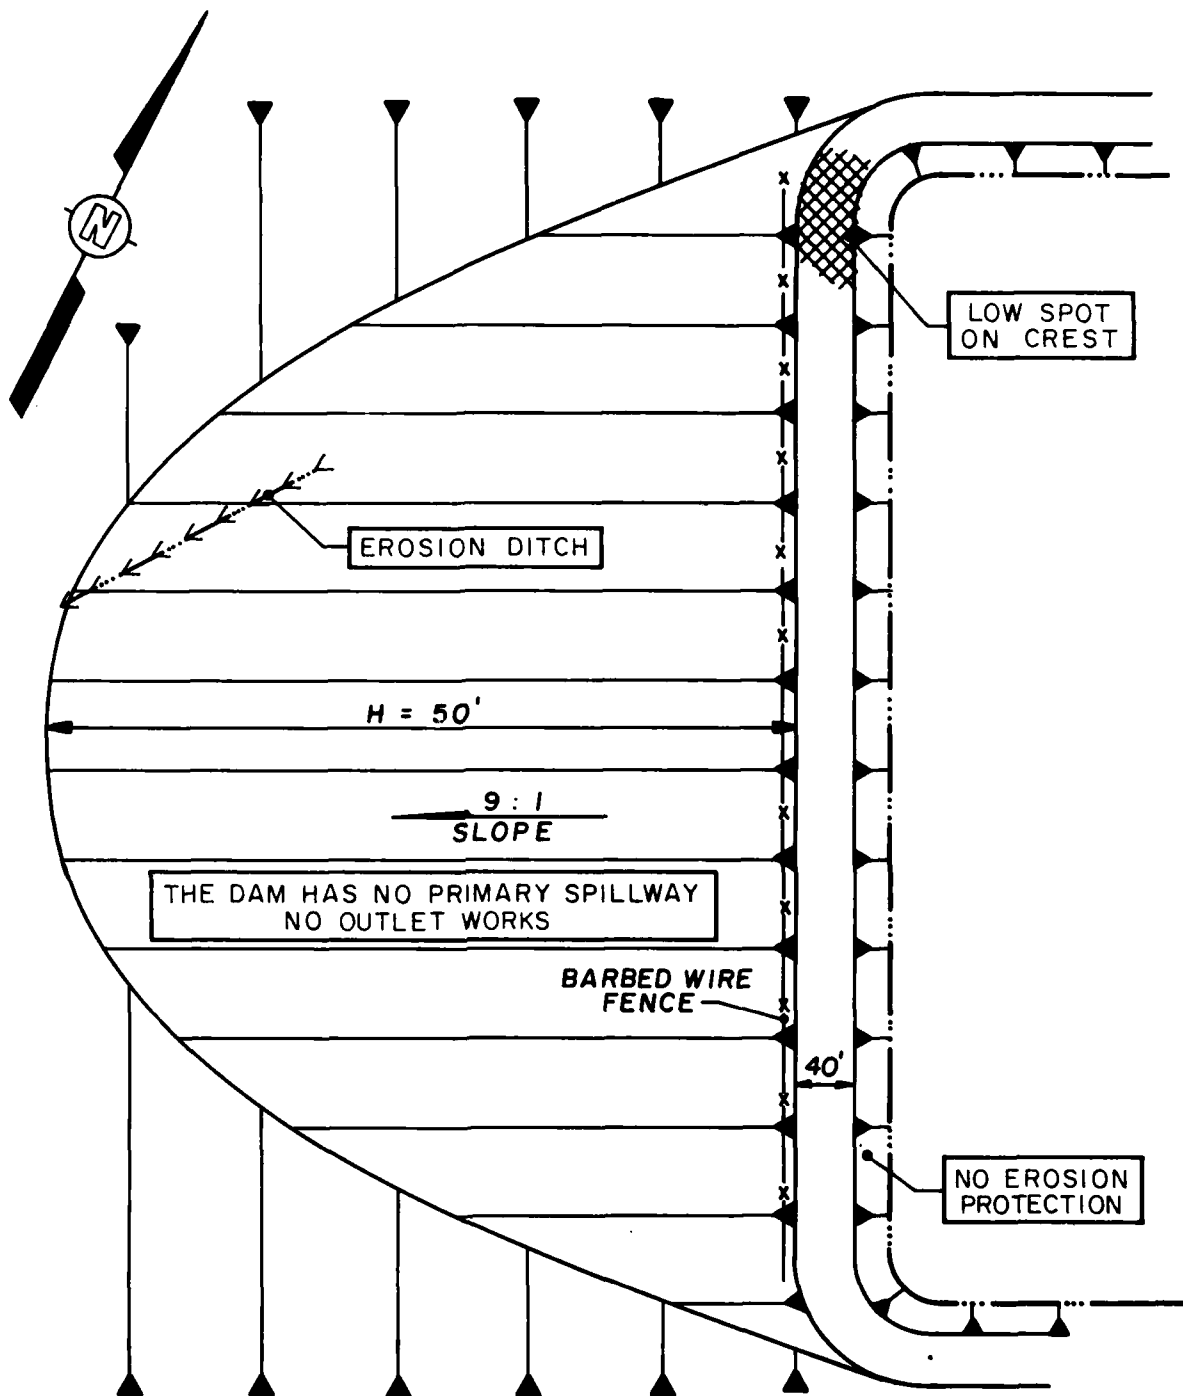
The specific observations are illustrated in Plate 3.

1. POOL LEVEL DATE OF INSPECTION:  
~5 FT. BELOW LOW SPOT ON CREST.

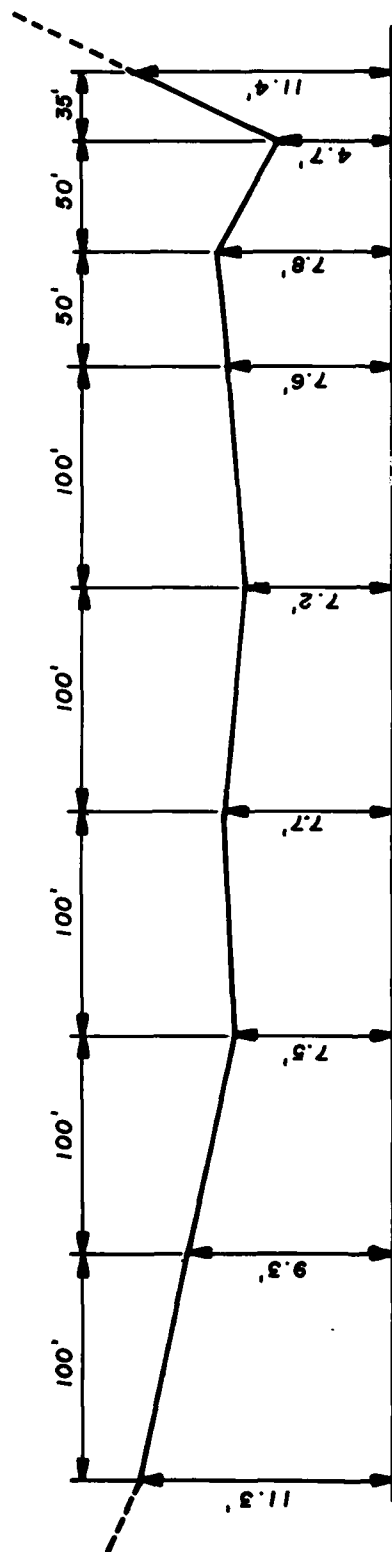
### DAM CREST PROFILE (LOOKING DOWNSTREAM)

d. Overtopping Potential. Various percentages of the PMF inflow hydrograph were routed through the reservoir, and it was found that the dam can impound less than 20 percent of the PMF without overtopping the low spot on the crest (Elevation 1404.7). For 40 percent of the PMF, it was found that only the low spot on the crest of the dam near the right abutment would be overtopped, and for 50 percent of the PMF, most of the crest would be overtopped for a duration of 4.8 hours with a maximum depth of about 0.5 foot.
